## Southampton Green

### 2017 Reserve Fund Study

May, 2017  
RJC# CAL.106642.0003

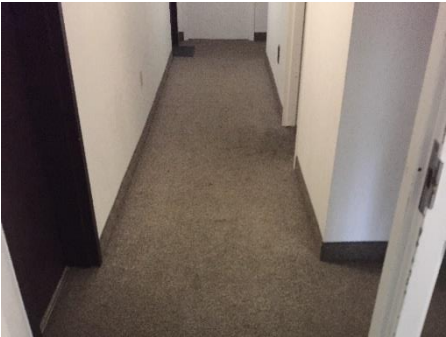
Photograph 1: Common Area Carpet

Common area carpet finishes were in marginal condition at the time of our review. Carpet was last replaced in 2008 for buildings 1, 4, and 5, and in remaining buildings in 2012. Areas of wear and stains were noted in various stairs and hallways. We have included a budget for replacement of the carpet. The clubhouse carpet is not included in this item.

Expected Normal Life:	15	Years
Present Equivalent Age:	9	Years
Estimated Remaining Life:	6	Years

Replacement budget: \$175,000

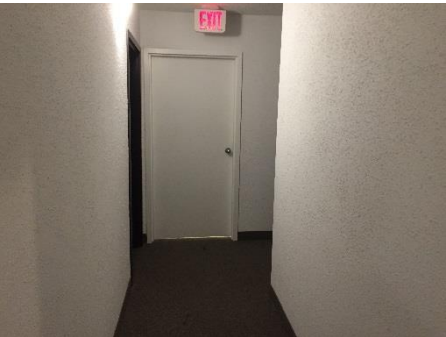
Photograph 2: Common Area Interior Doors

Overall, the common area doors appeared to be in good condition. Door sizes, styles and construction vary throughout the building. Included are insulated and non-insulated hollow metal doors, and wood core doors. We noted that select fire rating labels located on the edges of the unit doors have been painted over. This should be avoided as it prevents future determination of whether or not the doors and frames are appropriately fire rated.

Replacement budget: \$300,000

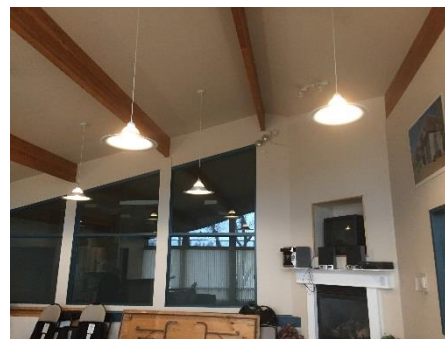
Photograph 3: Clubhouse Main Floor Finishes

Expected Normal Life:	15	Years
Present Equivalent Age:	11	Years
Estimated Remaining Life:	4	Years

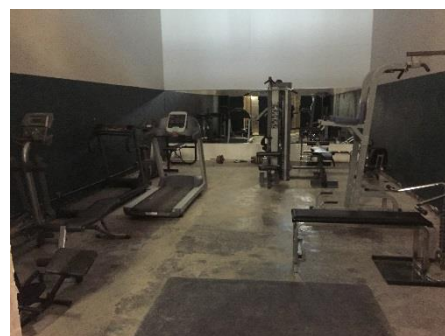
Photograph 4: Clubhouse Fitness Equipment

Expected Normal Life:	15	Years
Present Equivalent Age:	8	Years
Estimated Remaining Life:	7	Years

Replacement budget: \$11,000

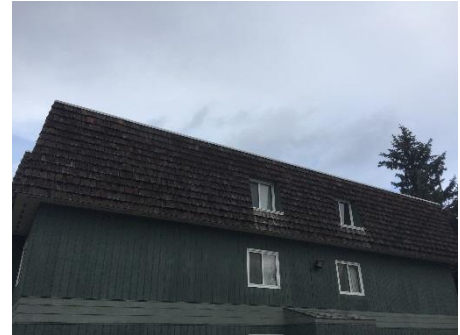
Photograph 5: Typical Mansard Roof

The faux mansard roof is clad with cedar shingles, which appeared to be in good condition at the time of our review. Selective repairs to the shingles were last completed in 2012. The following allowance allows for selective repairs to the cedar shingles.

Expected Normal Life:	10	Years
Present Equivalent Age:	5	Years
Estimated Remaining Life:	5	Years

Restoration budget: \$100,000

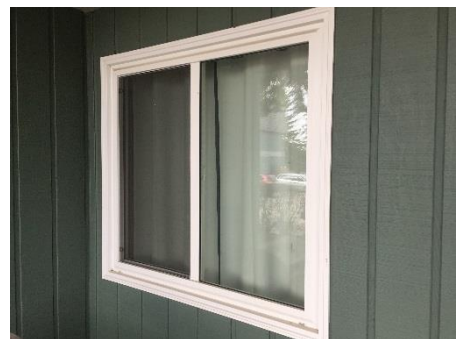
Photograph 6: Operable Residential Window

In general, the windows appeared to be in good condition; however, as the units begin to age their condition will vary with the level of exposure to the elements. Various approaches to phasing the window replacement may be considered at the time of replacement.

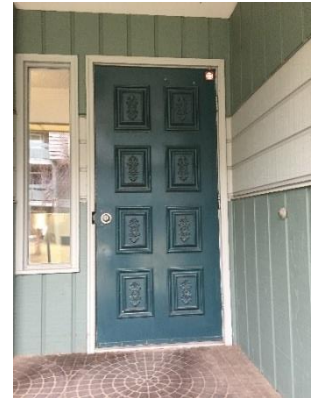
Photograph 8: Residential Entrance Door

Insulated hollow core metal framed doors provide access into and out of the building. The board has indicated that 24 entrance doors will be replaced by the end of 2017. We have assumed the remaining doors would be replaced in 2018.

Expected Normal Life:	35	Years
Present Equivalent Age:	35	Years
Estimated Remaining Life:	0	Year

Replacement budget: \$90,000  
Budget provided by Board

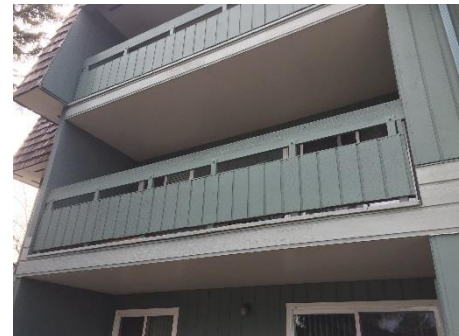
Photograph 9: Typical Balcony Railing

Painted metal railings with painted cedar wood infills are used to enclose the balconies. The metal railings and wood appeared to be in reasonable condition at the time of our review. It is assumed that the metal railings will be serviceable for the life of the complex. The following budget includes restoration of the railings, including application of exterior paint and selective replacement of deteriorated wood infill.

Expected Normal Life:	5	Years
Present Equivalent Age:	1	Year
Estimated Remaining Life:	4	Years

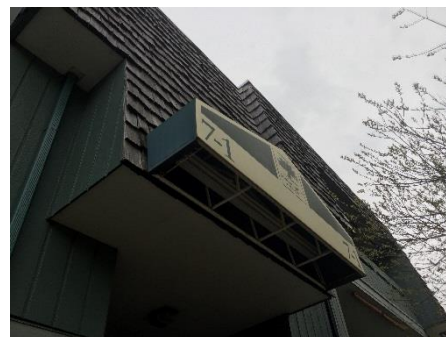
Photograph 10: Typical Entrance Awning

A canvas awning supported by metal framing is located above the front main entrance to each pod. The awnings appeared to be in reasonable condition at the time of our review. We have assumed the metal support framing will be reused during future replacements. We have allowed for replacement of the awning canvas in the reserve fund calculations.

Expected Normal Life:	20	Years
Present Equivalent Age:	13	Years
Estimated Remaining Life:	7	Years

Replacement budget: \$50,000

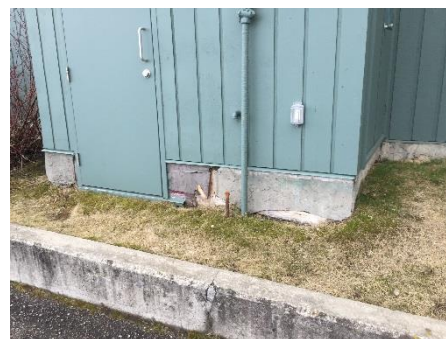
The foundation walls around the building perimeter have been covered with a concrete parging. Cracking and delamination of the parging was observed in isolated locations, exposing the building paper and sheathing beneath. Installation of new parging materials and repair of the existing parging can be expected over the life of the building. A selective repair allowance has been included.

Photograph 11: Delaminated Parging

Expected Normal Life:	15	Years
Present Equivalent Age:	12	Years
Estimated Remaining Life:	3	Years

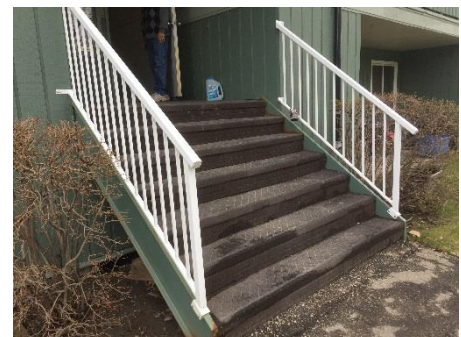
Photograph 12: Typical Entranceway  
Staircase Railing

Railings are located throughout the complex at the sides of staircases and are comprised of prefinished metal rails and pickets at building entranceways. The railings appeared to be in good condition at the time of our review. We have included the following budgets to perform replacement of the metal railings.

Expected Normal Life:	45	Years
Present Equivalent Age:	6	Years
Estimated Remaining Life:	39	Years

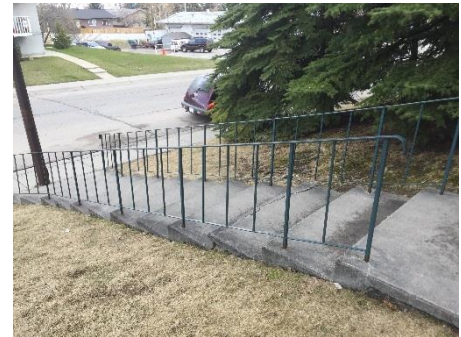
Photograph 13: Typical Walkway Railing

Painted steel railings, which appear to be of original construction, are provided at walkway staircases throughout the complex. Surface corrosion was observed on select railing at the time of our review. We have included the following budgets to perform replacement of the metal railings. Painting of the steel railings is assumed to be included in the operations and maintenance budgets.

Expected Normal Life:	45	Years
Present Equivalent Age:	27	Years
Estimated Remaining Life:	18	Years

Replacement budget: \$15,000

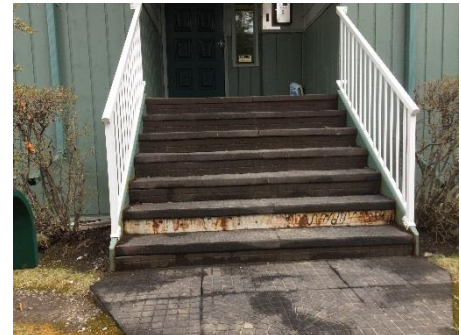
Photograph 14: Typical Steel Staircase

Steel staircases covered with rubber coverings are provided at the entrances to the residential pods. During our review, advanced corrosion was observed on the underside of the staircases. Some staircases are nearing the end of their service life. The following budget includes an allowance for select replacement of the steel staircases. We expect rubber staircase coverings will be replaced on an as-needed basis out of the operations and maintenance budget.

Expected Normal Life:	7	Years
Present Equivalent Age:	2	Years
Estimated Remaining Life:	5	Years

Replacement budget: \$25,000

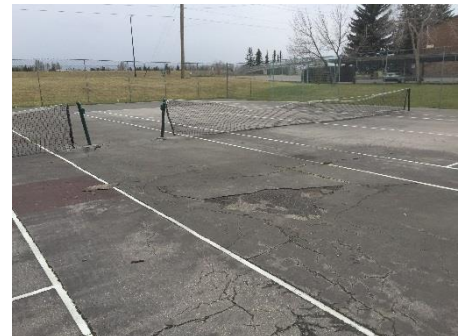
Photograph 15: Tennis Court

Two exterior tennis courts are provided behind the clubhouse. We understand that the board wishes to replace the existing tennis court with one or two half-court basketball courts and one tennis court. The following includes for milling and resurfacing of the asphalt.

Expected Normal Life:	25	Years
Present Equivalent Age:	24	Years
Estimated Remaining Life:	1	Year

**Asphalt overlay budget: \$25,000**

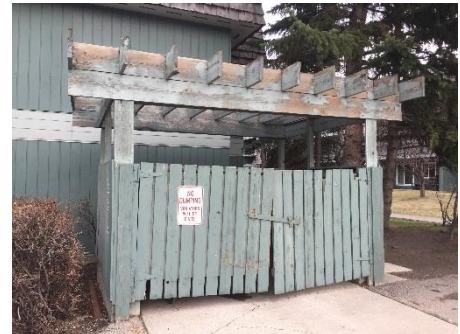
Photograph 16: Original Garbage Enclosure

Expected Normal Life:	25	Years
Present Equivalent Age:	25	Years
Estimated Remaining Life:	0	Years

Replacement budget: \$10,000

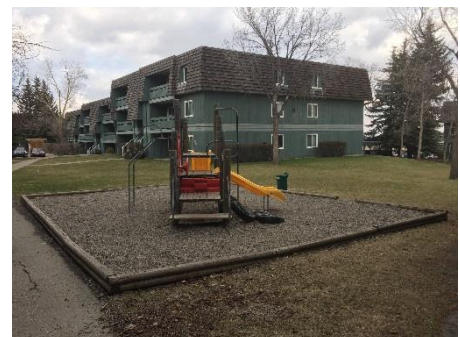
Photograph 17: Playground Equipment

A small playground is located at the center of the complex. We did not observe any deficient conditions. The following budget includes select repair and replacement of various components.

Expected Normal Life:	25	Years
Present Equivalent Age:	17	Years
Estimated Remaining Life:	8	Years

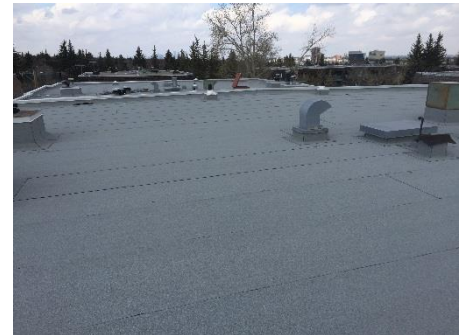
Photograph 18: Typical SBS Roof

The roof systems on buildings 1, 3, 4, 6, 7, and 8 consist of a conventional SBS modified sheet membrane. We were not informed of any moisture ingress through the roof membrane at the time of our review. A budget has been included for total replacement of the roof assembly including membranes and flashings.

Expected Normal Life:	25	Years
Present Equivalent Age:	9	Years
Estimated Remaining Life:	16	Years

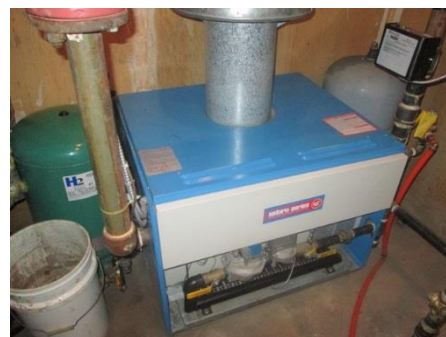
Photograph 19: New Heating Boiler

Twenty-four heating boilers of various manufacturers, sizes and energy efficiency are installed in the mechanical rooms throughout the complex. It is our understanding that the boilers are being replaced on an "as needed basis". Glycol, is currently the preferred chemical treatment for these systems.

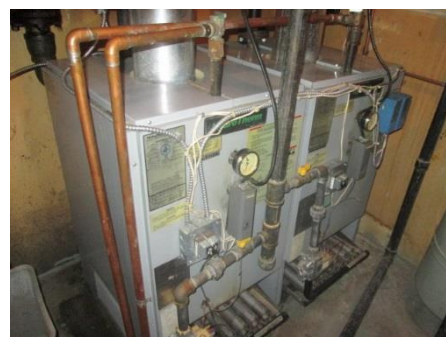
Photograph 20: Old Model Boiler

Expected Normal Life:	30	Years
Present Equivalent Age:	12	Years
Estimated Remaining Life:	18	Years

Replacement budget: \$130,000

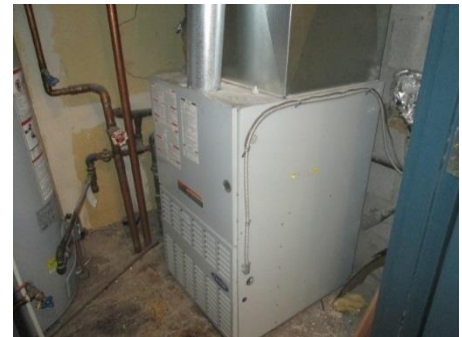
Photograph 21: Clubhouse Furnace

Expected Normal Life:	25	Years
Present Equivalent Age:	17	Years
Estimated Remaining Life:	8	Years

Replacement budget: \$9,000

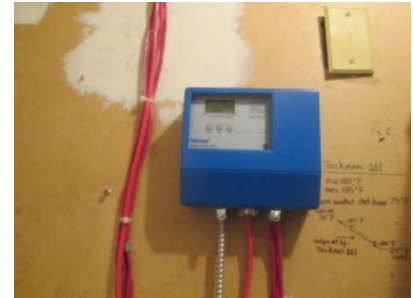
Photograph 22: New Boiler Control

Expected Normal Life:	20	Years
Present Equivalent Age:	4	Years
Estimated Remaining Life:	16	Years

Replacement budget: \$3,000

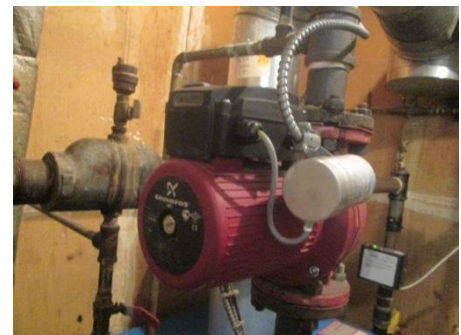
Photograph 23: New Heating Pump

Expected Normal Life:	25	Years
Present Equivalent Age:	18	Years
Estimated Remaining Life:	7	Years

Replacement budget: \$8,000

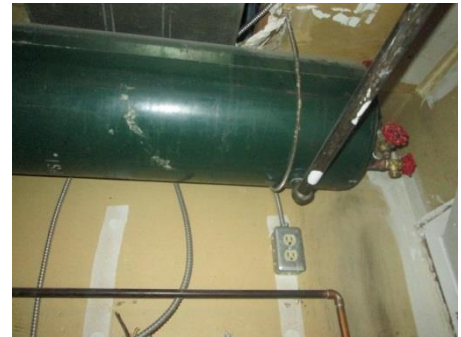
Photograph 25: Expansion Tank

Expected Normal Life:	30	Years
Present Equivalent Age:	27	Years
Estimated Remaining Life:	3	Years

Replacement budget: \$6,000

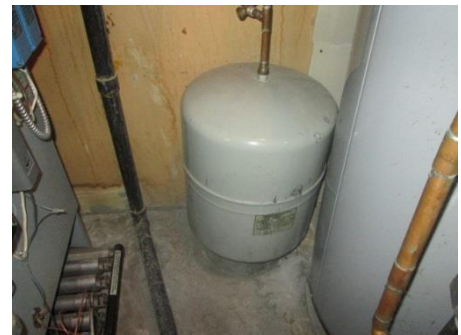
Photograph 26: Cushion Tank

Expected Normal Life:	30	Years
Present Equivalent Age:	12	Years
Estimated Remaining Life:	18	Years

Replacement budget: \$26,000

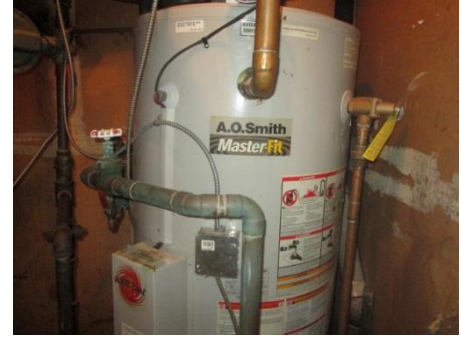
Photograph 27: Common Domestic Water Heater

Housed in the mechanical rooms of each building are domestic water heaters comprised from various manufacturers with varying degrees of energy and size. These heaters supply heated domestic water to the residents.

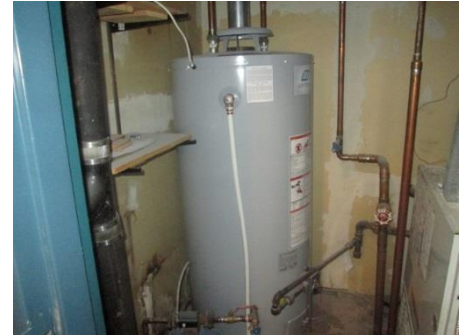
Photograph 28: Clubhouse Domestic Hot Water Heater

Expected Normal Life:	15	Years
Present Equivalent Age:	1	Year
Estimated Remaining Life:	2	Years

Replacement budget: \$3,000

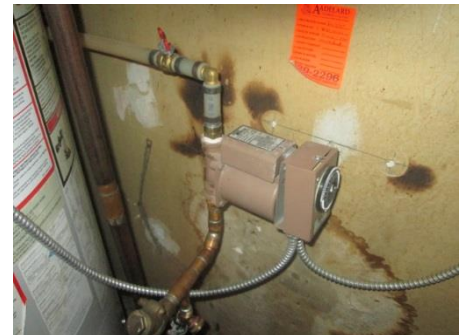
Photograph 29: Domestic Hot Water Recirculation Pump

Expected Normal Life:	15	Years
Present Equivalent Age:	12	Years
Estimated Remaining Life:	3	Years

Replacement budget: \$40,000

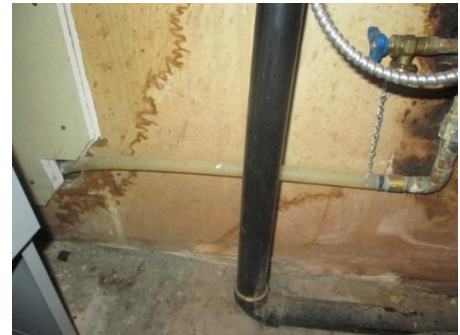
Photograph 30: PEX Piping

This system was not originally installed with the use of PEX piping. Recent history has identified some problems with some types of PEX piping. It is recommended that this system remain a copper and brass system and that the current PEX piping installed be monitored.

The actual timing of the replacement and costs will be influenced by factors such as the quality, quantity and configuration of the piping and its installation and the quality of interior finishes that will be affected during the work. The timing of the replacement of the piping will be a function of the rate of failure that occurs in the building. Isolated leaks can be repaired on an "as needed" basis; however, replacement should be considered when frequency and extent of leaks increases significantly. Monitoring and recording dates and locations of pipe leaks will help to determine when a replacement program should be implemented. Also, ultra-sonic testing of selected areas of piping can be completed in the future to determine remaining pipe wall thickness. This is a non-destructive test that could help to provide information on localized areas of the pipe and may help to predict the condition of the system and when replacement is necessary. The present equivalent age and expenditure spread have been adjusted to indicate a long term phased replacement

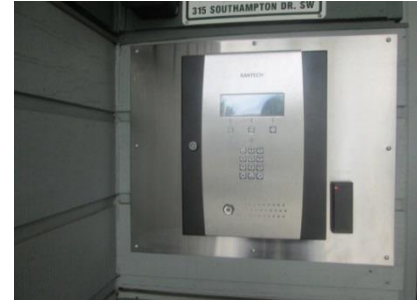
Photograph 31: New Intercom

Expected Normal Life:	20	Years
Present Equivalent Age:	0	Year
Estimated Remaining Life:	20	Years

Replacement budget: \$72,000

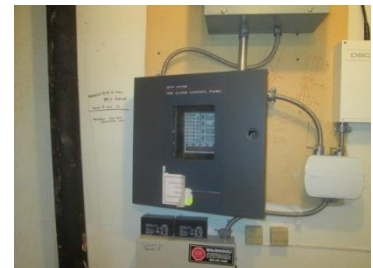
Photograph 32: Typical Fire Alarm Panel

Various manufacturer brands of fire panels have been installed throughout the property. Upgrades of these panels is being completed on an "as needed basis".
